# Environmental Impact and Health Assessment of Berry Pond Leopold's Preserve, Prince William County, Virginia

Elisa Dass  
Field Conservation Intern  
Wildlife Conservation student, Virginia Tech  
College of Natural Resources and Environment

Supervisor: Nick Davis  
Land Stewardship Manager  
Leopold's Preserve

Date: August 16, 2026

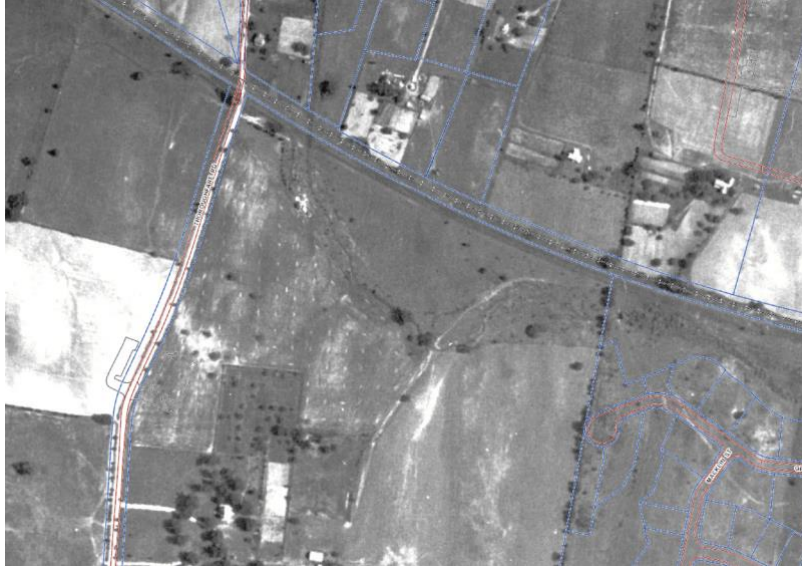
*Figure 1a. Aerial imagery of the Berry farm before Berry Pond was established, 1937.  
Source: Prince William County Mapper.*

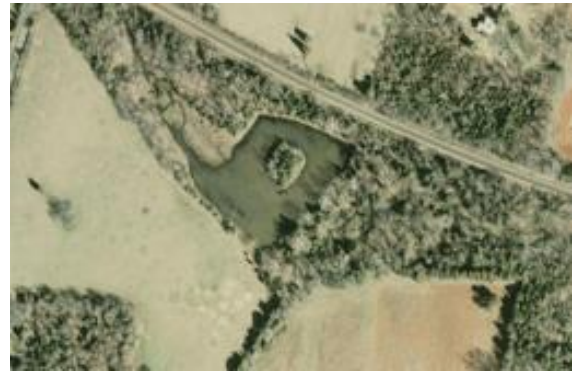
**Figure 1d.** Aerial imagery from 2000 of Berry Pond, ~67,000 square feet/~1.5 acres  
Source: Prince William County Mapper

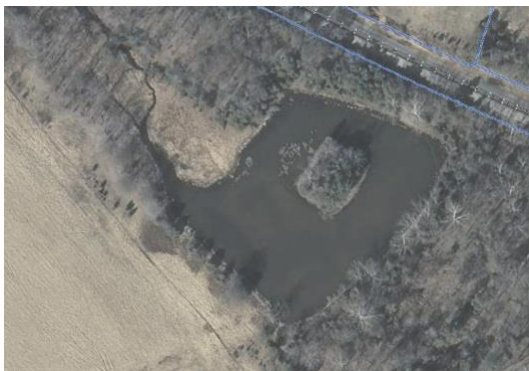
**Figure 1e.** Aerial imagery from 2016 of Berry Pond, ~64,000 square feet/~1.5 acres.  
Source: Prince William County Mapper

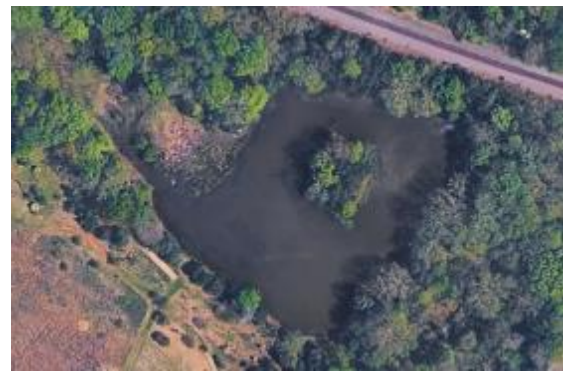
**Figure 1f.** Aerial imagery from 2026 of Berry Pond, ~73,000 square feet/~1.7 acres  
Source: Google Earth.

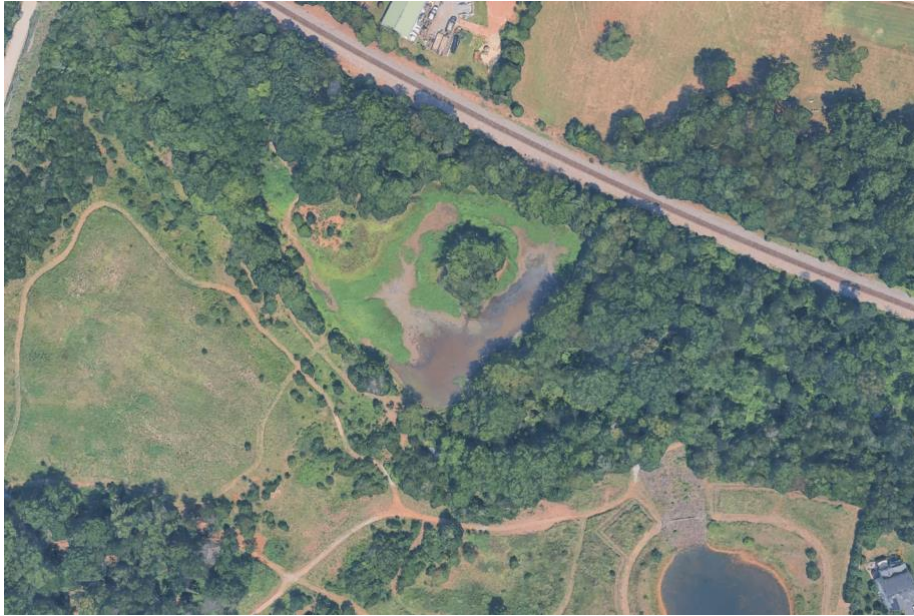
In 2022, heavy rainfall destroyed a beaver dam, breaching the pond and causing significant drainage. Berry Pond reached its lowest water level during a drought in 2023. Although no depths were recorded at the time, multiple accounts described sections that are now underwater as walkable and dry (Davis, 2026).

*Figure 1g. Aerial imagery from 2023 of Berry Pond dried up. Source: Google Earth.*

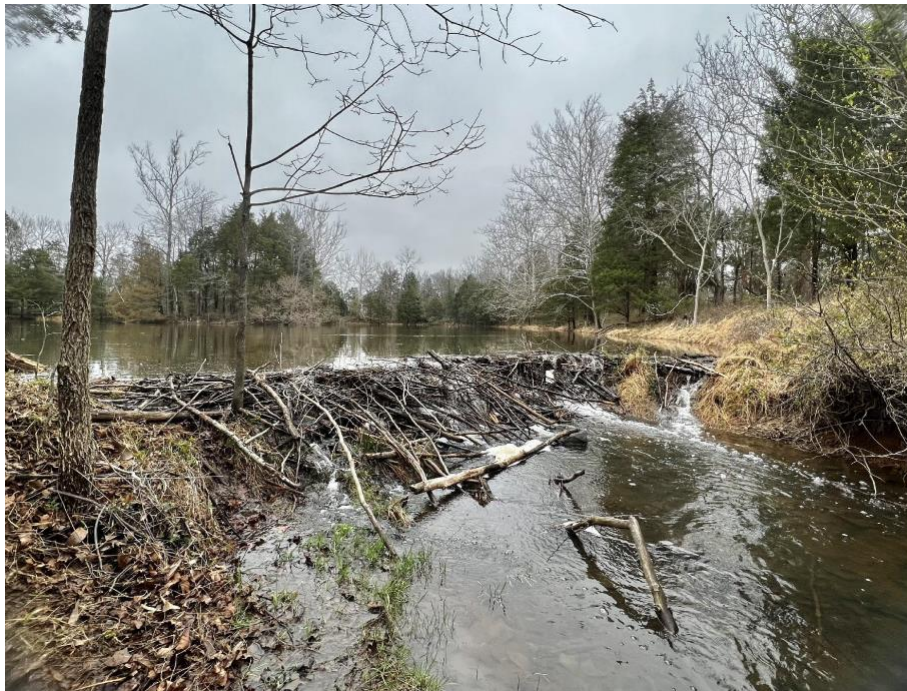
*Figure 1h. Image from 2022 of the original beaver dam. Source: Nick Davis.*

Staff and volunteers at Leopold’s Preserve attempted to rebuild the dam, but storms washed away the first two attempts. On the third attempt, the dam was successfully rebuilt. In the winter of 2025, beavers returned and further restored the structure. The effects were visible within months: water levels rose, and the pond expanded substantially.

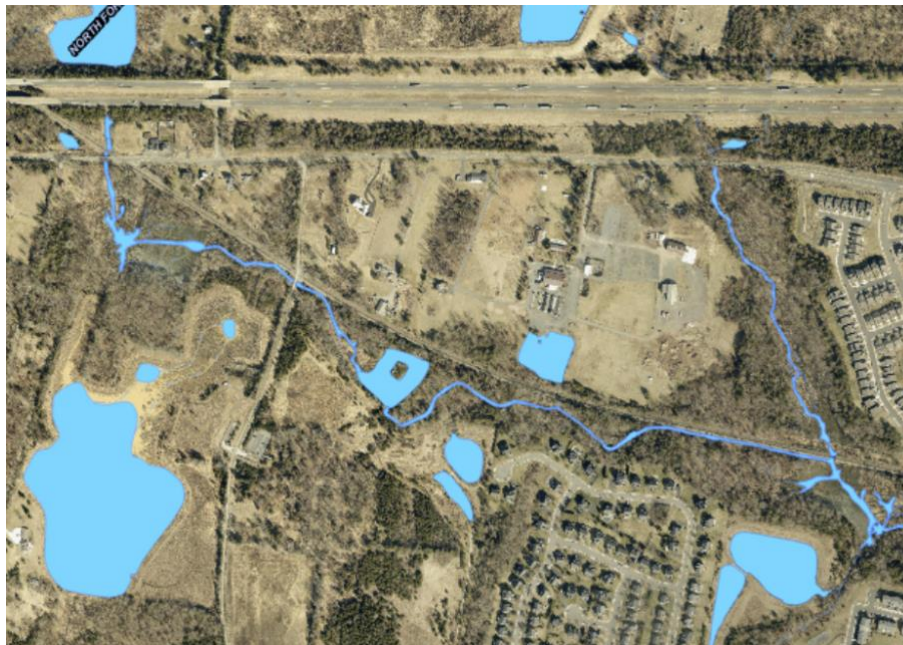
**Figure 2b.** Aerial imagery of Berry Pond and surrounding bodies of water. Source: Prince William County Mapper.

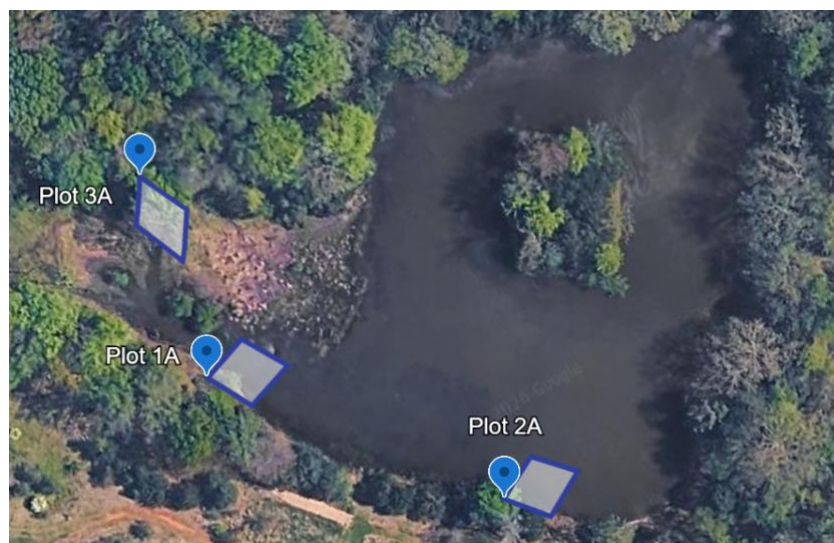
Three plots (10 meters by 10 meters) were established across the southern end of the pond. Within each plot, field technicians conducted vegetation and benthic macroinvertebrate surveys. Plot 1 (Corner A:  $38^{\circ}49'02.45''\text{N}$ ,  $77^{\circ}40'21.96''\text{W}$ ) was selected as the first site due to its historical significance. During the 2023 drought, this site was completely dry and grassy (Figure 1g). The willow oaks (*Quercus phellos*) that grew between corner 1D:  $38^{\circ}49'02.55''\text{N}$ ,  $77^{\circ}40'21.57''\text{W}$  and corner 1C:  $38^{\circ}49'02.26''\text{N}$ ,  $77^{\circ}40'21.35''\text{W}$  are now semi-submerged, serving as a useful reference for water-level changes. Plot 2 (Corner A:  $38^{\circ}49'00.82''\text{N}$ ,  $77^{\circ}40'20.35''\text{W}$ ) was selected for its proximity to the beaver dam and the limnetic zone. As shown in Figure 1g, it was part of the original pond that did not dry up in 2023, making it a feasible comparison to Plot 1. Plot 3 (Corner A:  $38^{\circ}49'03.72''\text{N}$ ,  $77^{\circ}40'21.52''\text{W}$ ) was chosen for its position within the inlet, near the stream catchment as it enters the pond. At this location, the pond bottom appeared rich and flocculent, and the water was muddy brown from suspended sediment.

**Figure 2c.** Beacons representing corner A for each of the established plots.  
Source: Google Earth.

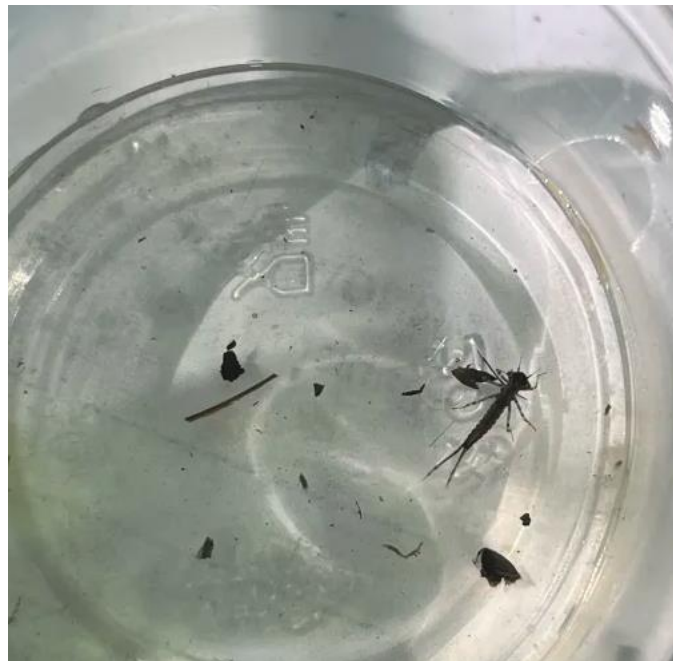
***Figure 4a.** Stonefly collected from the inflow stream in a portion cup for identification. Source: Elisa Dass.*

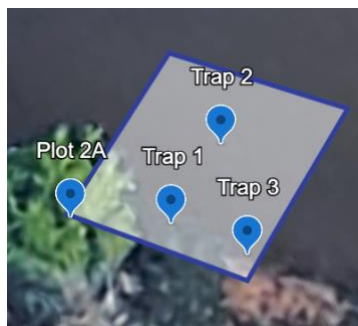
**Figure 4c.** Locations of traps in Plot 2. Source: Google Earth.

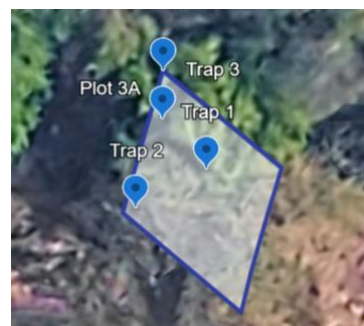
**Figure 4d.** Locations of traps in Plot 3. Source: Google Earth.

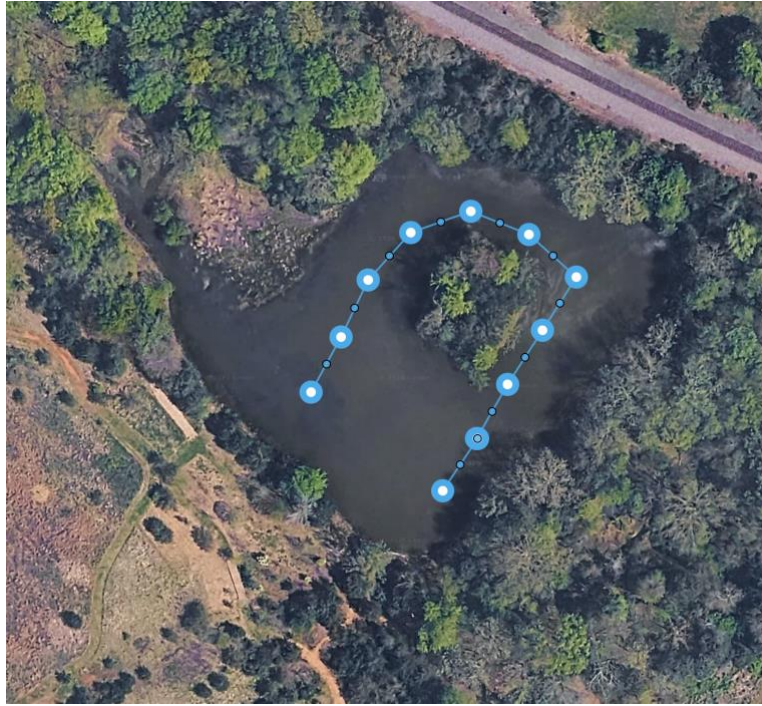
Fish specimens were collected with a seine net measuring 10 feet in length and 4 feet in height. Sampling locations were established at 50-foot intervals around the pond, resulting in a transect length of approximately 500 feet. For context, Berry Pond covers approximately 1.7 acres (about 73,000 square feet), so a focused assessment was conducted on a representative portion of the waterbody. Using the net dimensions and surveyed area, a rough estimate of fish abundance can be calculated.

**Figure 5a.** Surveyed area and spatial distribution of sampling points. Source: Google Earth.

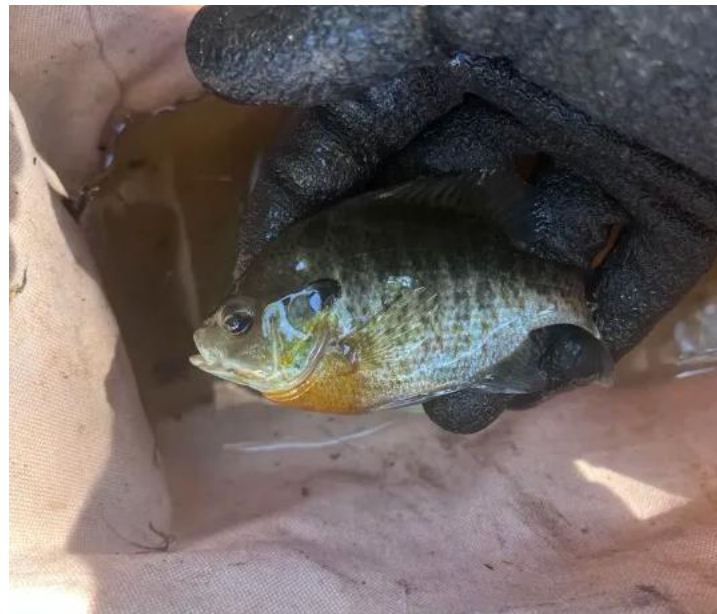
**Figure 5b.** Captured Bluegill (*Lepomis macrochirus*). Source: Elisa Dass.

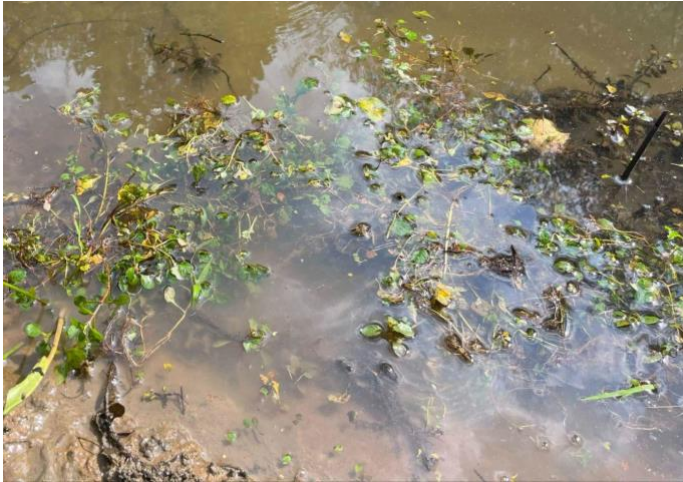
**Figure 6a.** Marsh seedbox (*Ludwigia palustris*) after initial transplanting. Source: Elisa Dass.

Native vegetation should be selected from nearby productive wetlands and transplanted carefully into designated areas around the pond, especially where shoreline erosion, sparse aquatic vegetation, or invasive pressure is most apparent. Suitable species include swamp rose mallow (*Hibiscus moscheutos*), soft rush (*Juncus effusus*), ditch stonecrop (*Penthorum sedoides*), dense St. John's wort (*Hypericum densiflorum*), marsh seedbox (*Ludwigia palustris*), false waterpepper (*Persicaria hydropiperoides*), and river bulrush (*Bolboschoenus fluviatilis*). These plantings would support the pond's transition into a more stable wetland ecosystem while reducing opportunities for invasive species to dominate.

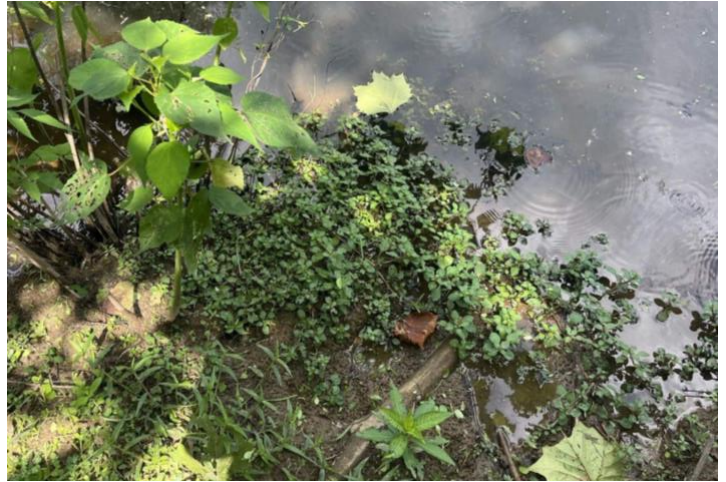
**Figure 6b.** Marsh seedbox (*Ludwigia palustris*) beginning to establish itself after one week. Source: Elisa Dass.
